Gold King Mine

Silverton, San Juan County, Colorado

0001/1408-01

PHOTOGRAPH LOG

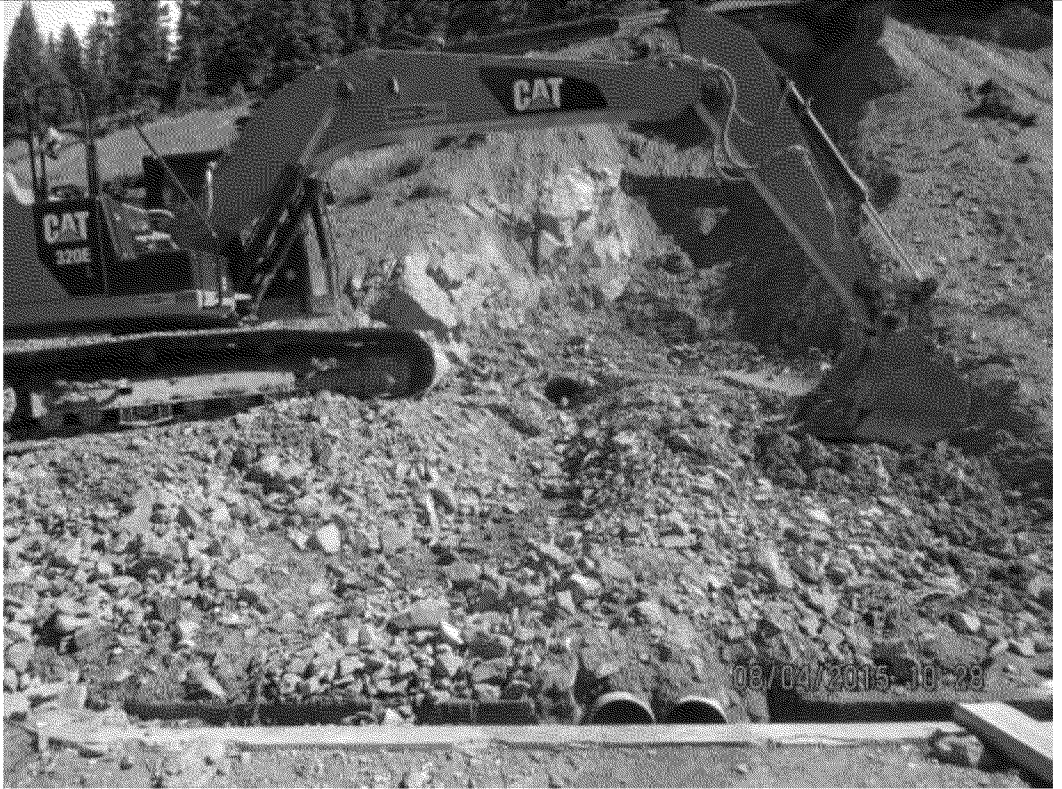
<p>Photo No. 1</p>	<p>Date: 08/04/2015</p>

<p>Direction Photo Taken:</p> <p>North</p>		
<p>Description: Beginning investigation into collapsed adit.</p>		
<p>Photo No. 2</p>	<p>Date: 08/04/2015</p>

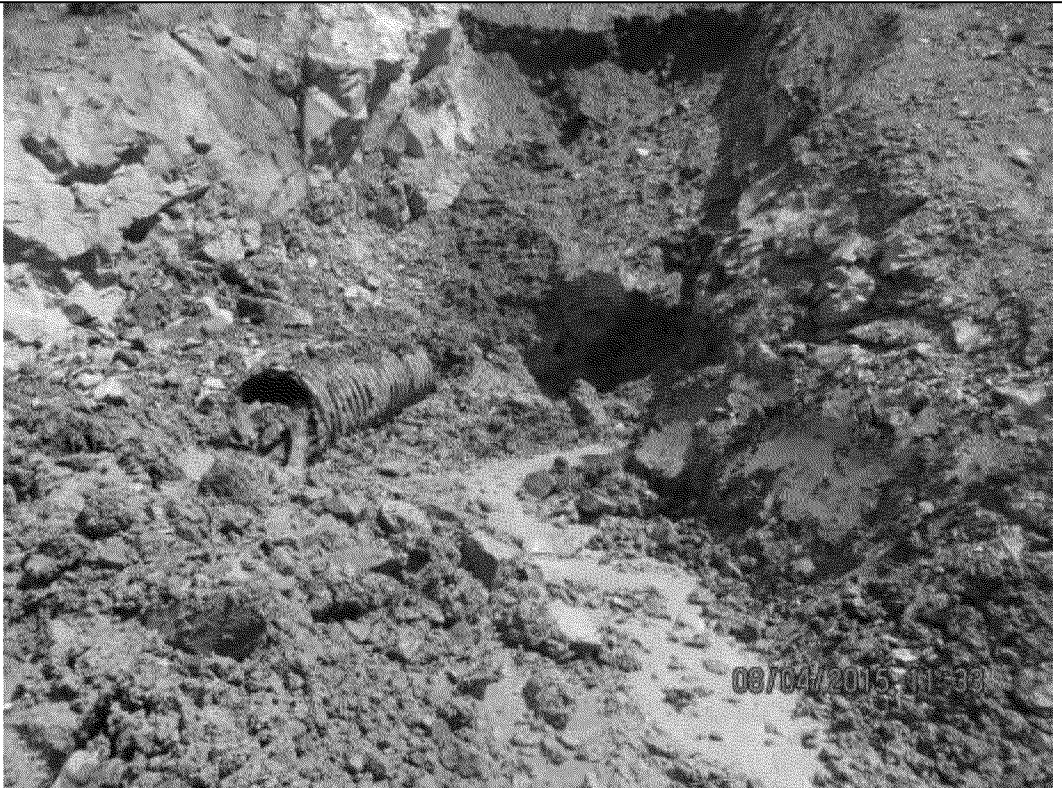
<p>Direction Photo Taken:</p> <p>North</p>		
<p>Description: Excavated next to DRMS-installed culvert, water muddy from soil disturbance.</p>

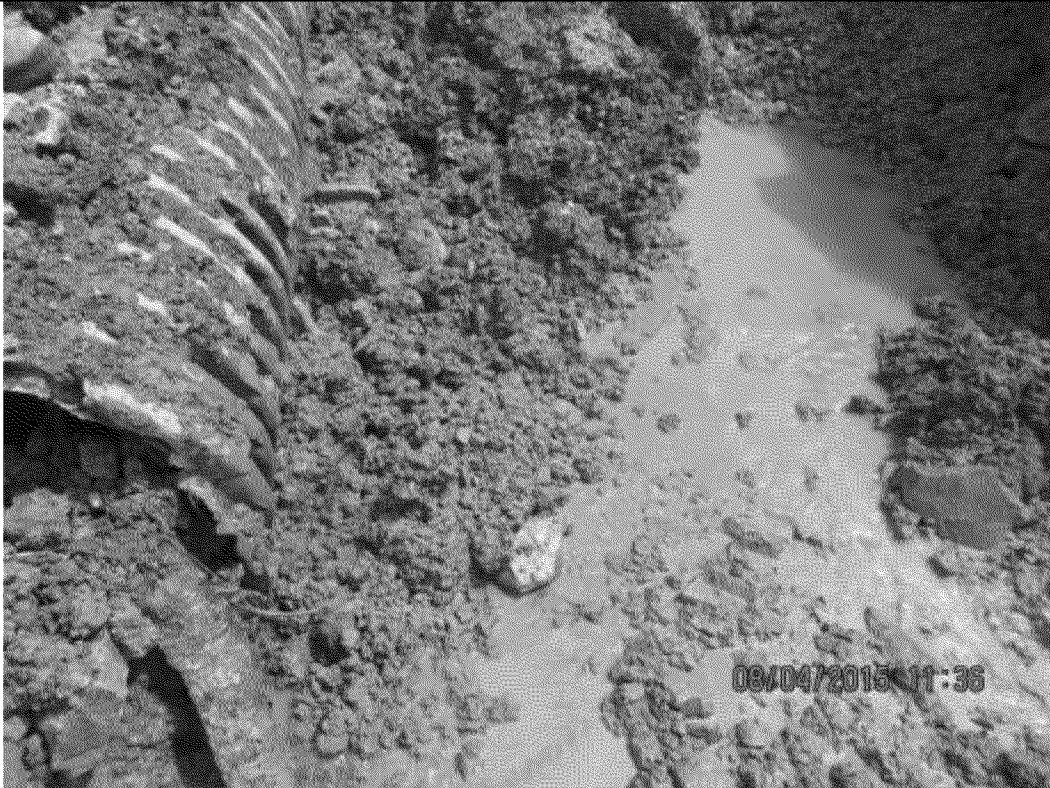
<p>Photo No. 3</p>	<p>Date: 08/04/2015</p>

<p>Direction Photo Taken:</p> <p>Down</p>		
<p>Description: Seepage from soil next to piping.</p>		
<p>Photo No. 4</p>	<p>Date: 08/04/2015</p>

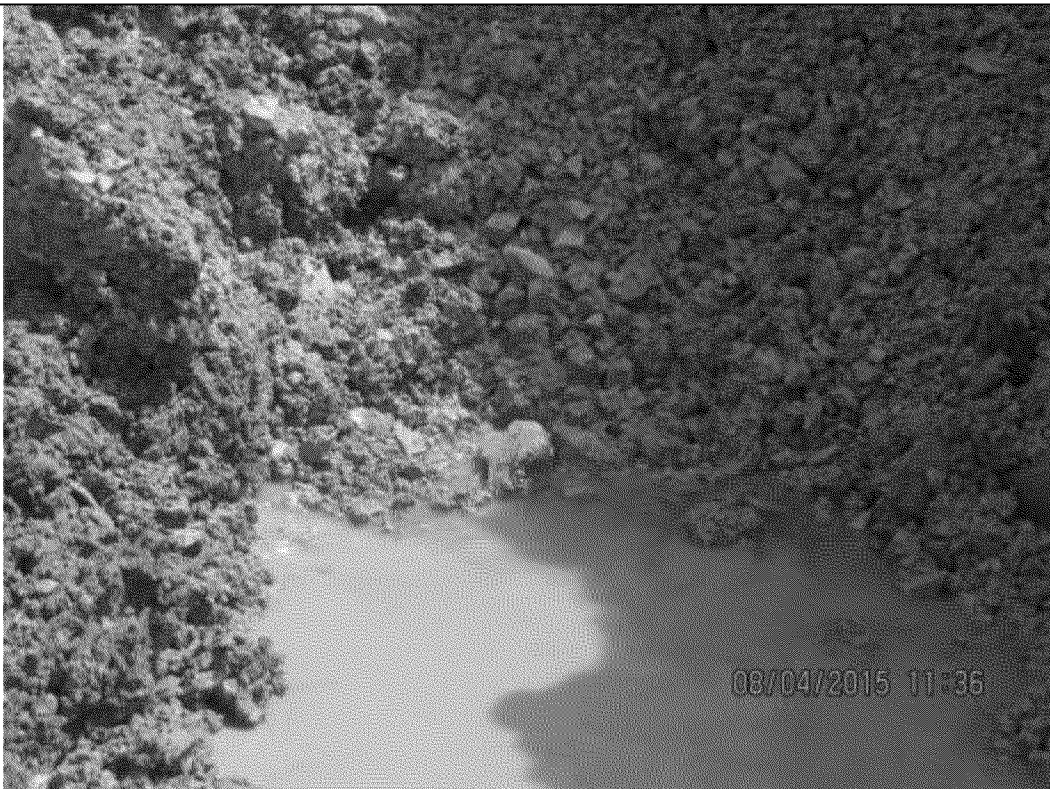
<p>Direction Photo Taken:</p> <p>Down</p>		
<p>Description: Seepage next to the pipe is clear until entering disturbed soil.</p>

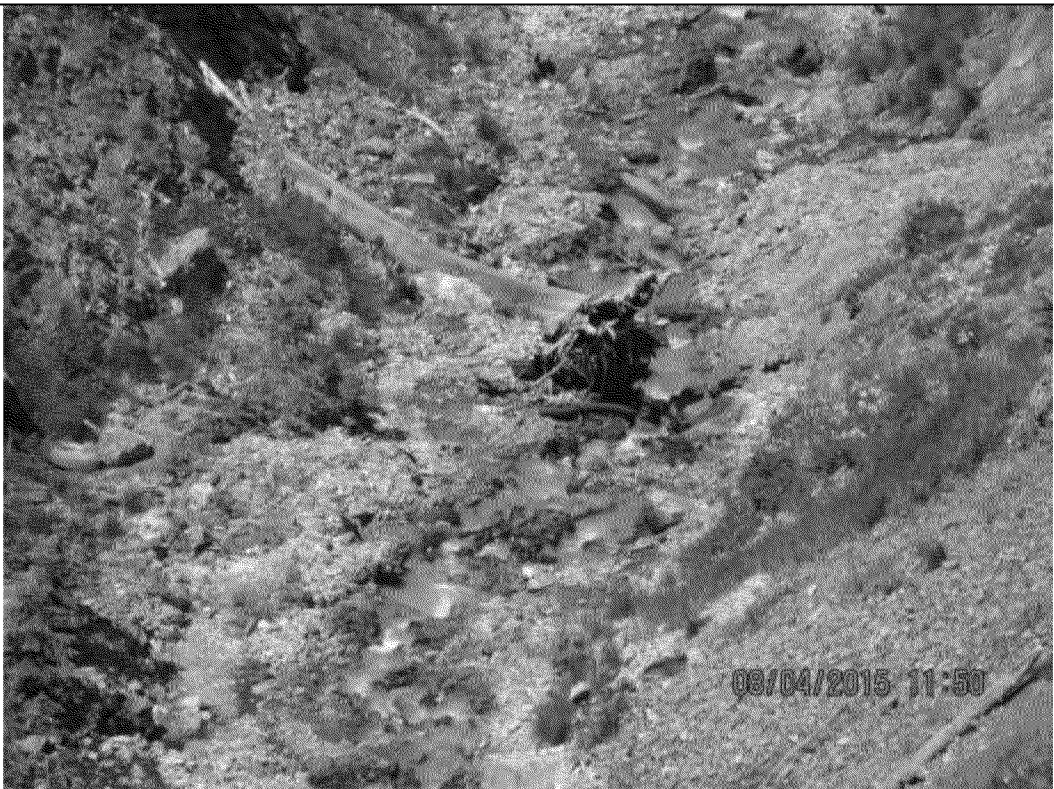
<p>Direction Photo Taken:</p> <p>West</p>		
<p>Description:</p> <p>Water minimally murky from disturbed soil and water entering the North Fork from site.</p>

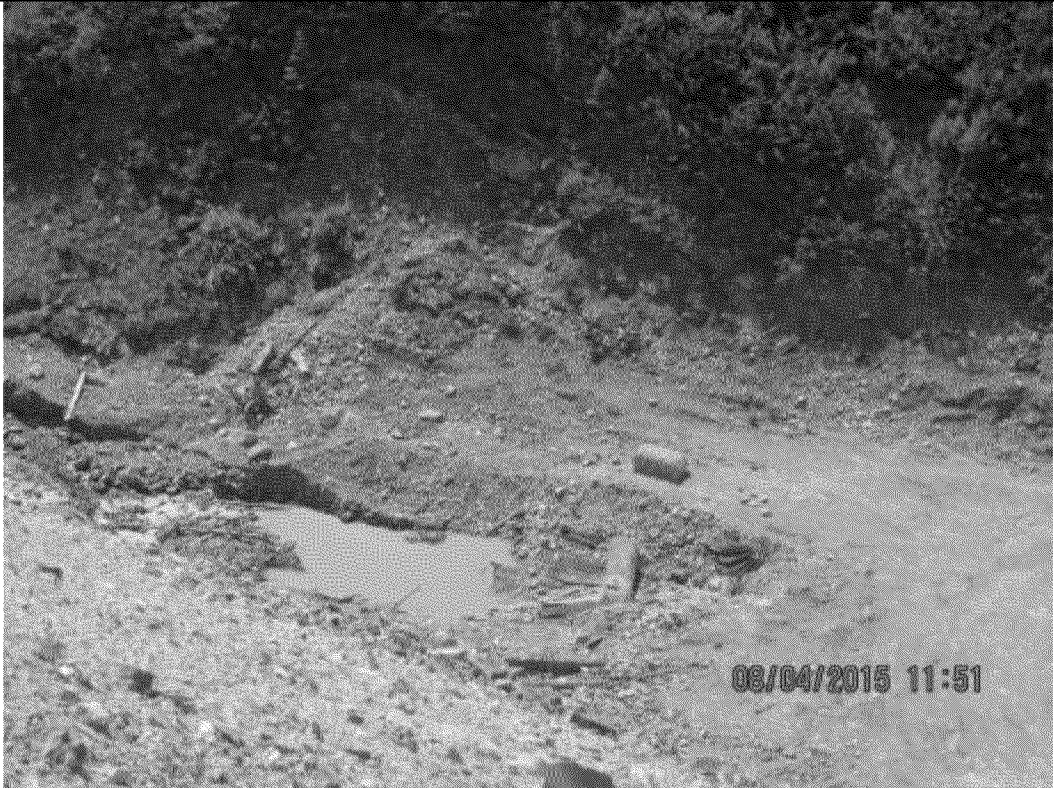
Photo No. 7	Date: 08/04/2015

Direction Photo Taken: South/Down		
Description: Hay bales installed as filter for sediment in North Fork.		
Photo No. 8	Date: 08/04/2015

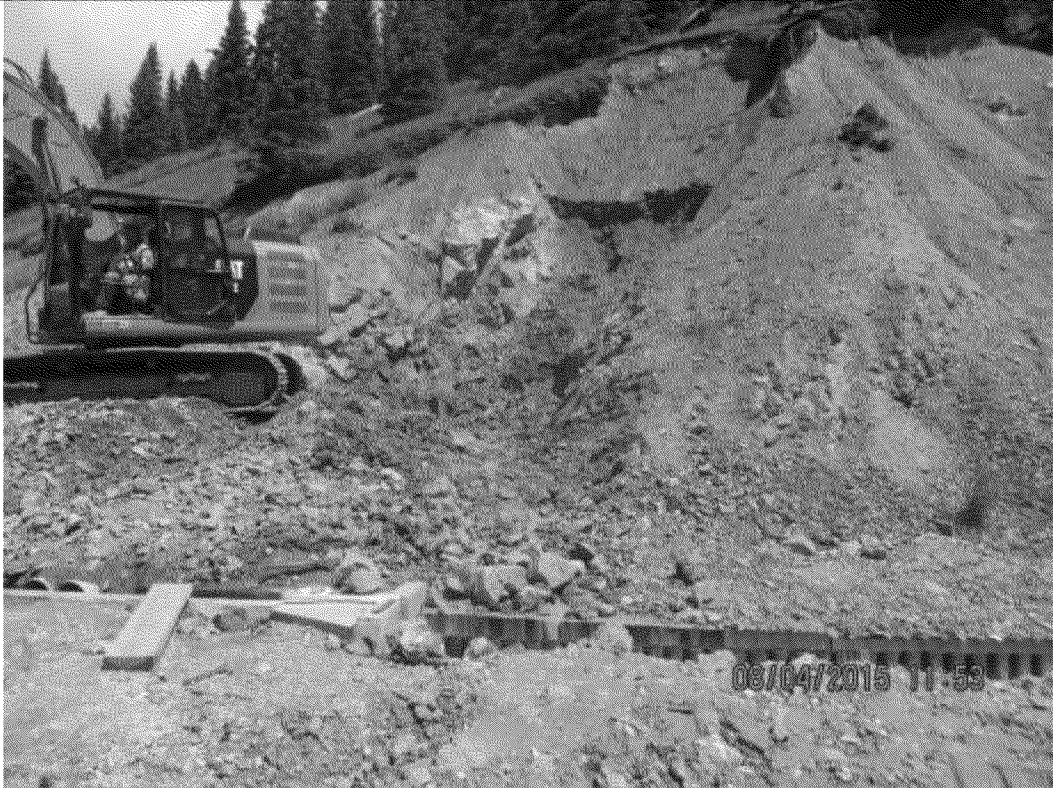
Direction Photo Taken: Northwest		
Description: Continuing excavation at the collapsed adit, no solid bedrock found for tunnel support.

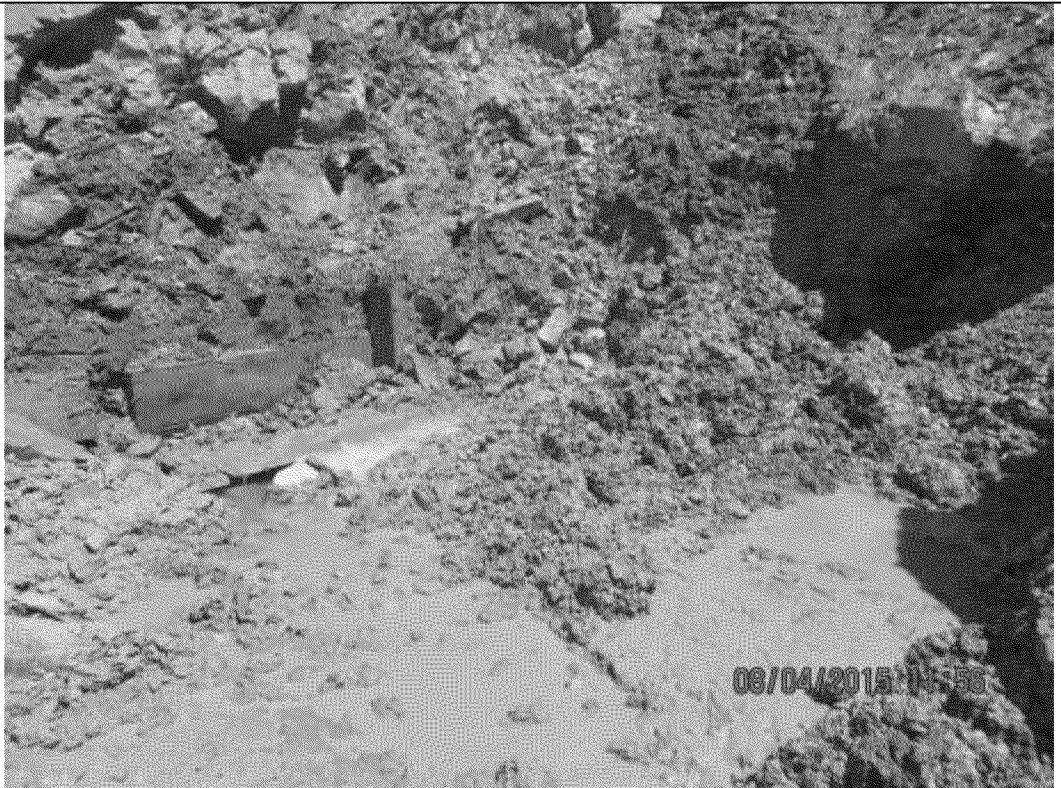
Photo No. 9	Date: 08/04/2015

Direction Photo Taken: Northeast		
Description: First signs of adit, support pillar with lagging.		
Photo No. 10	Date: 08/04/2015

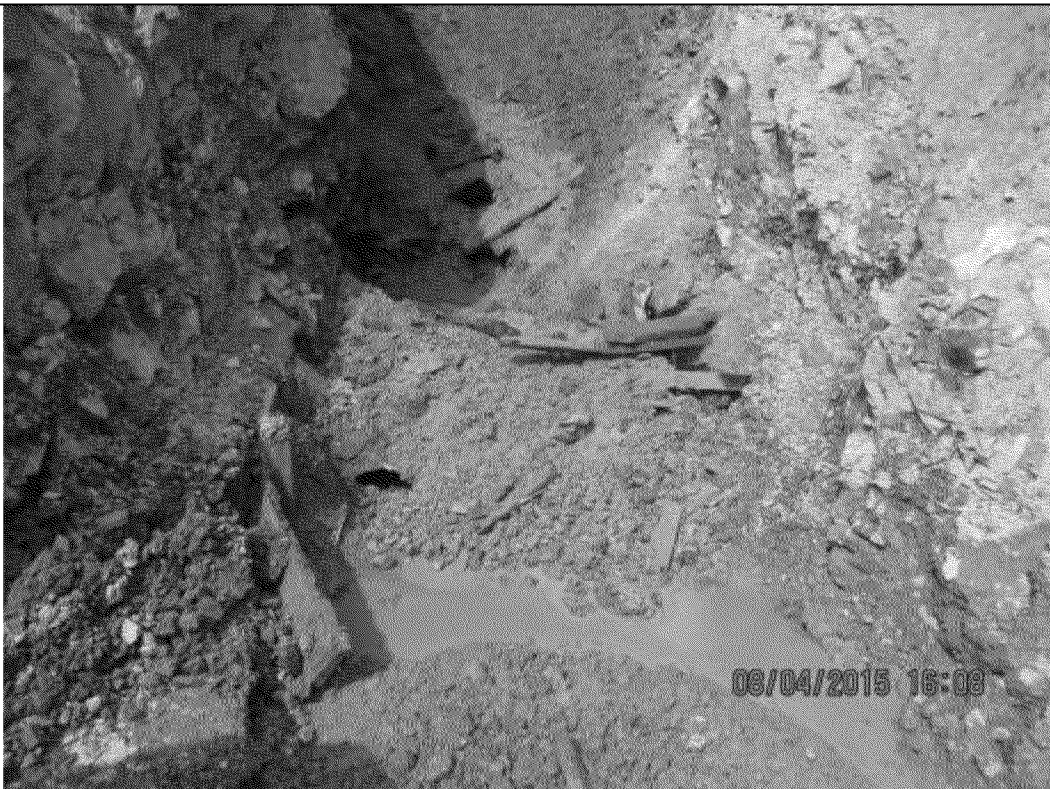
<p>Direction Photo Taken:</p> <p>North</p>		
<p>Description:</p> <p>Collapsed supports uncovered above anticipated adit, no sign of bedrock above the adit area.</p>

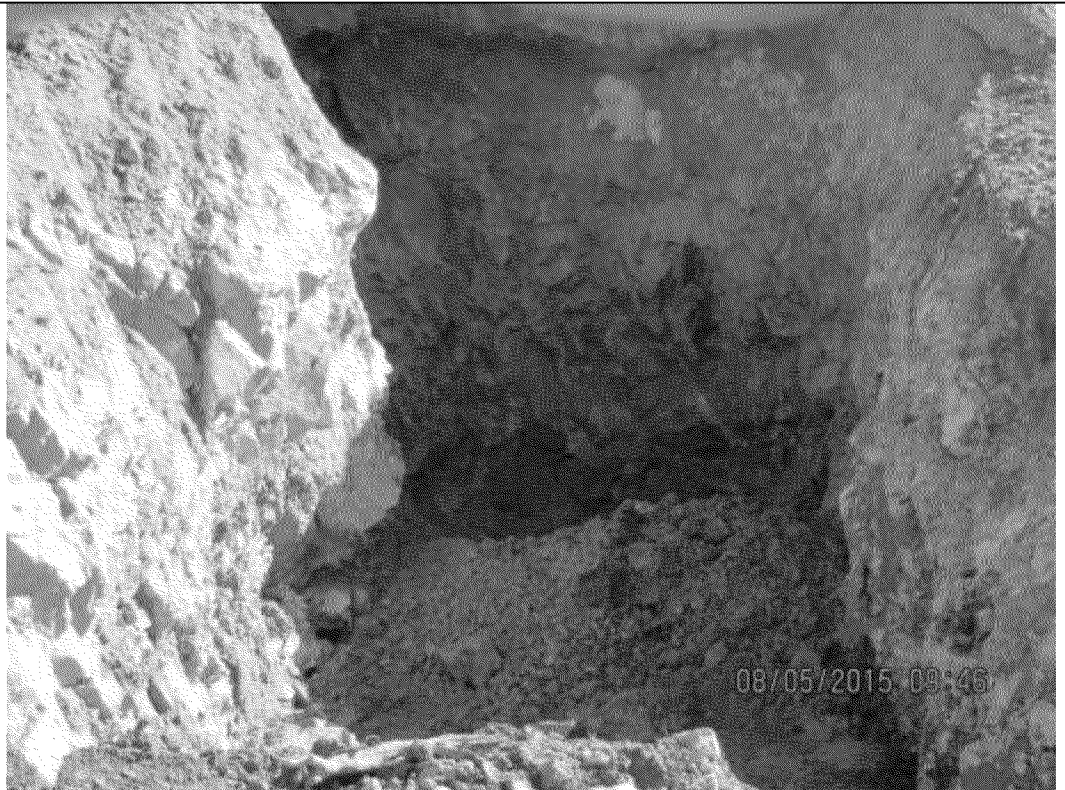
Photo No.
15

Bedrock found above the anticipated adit.

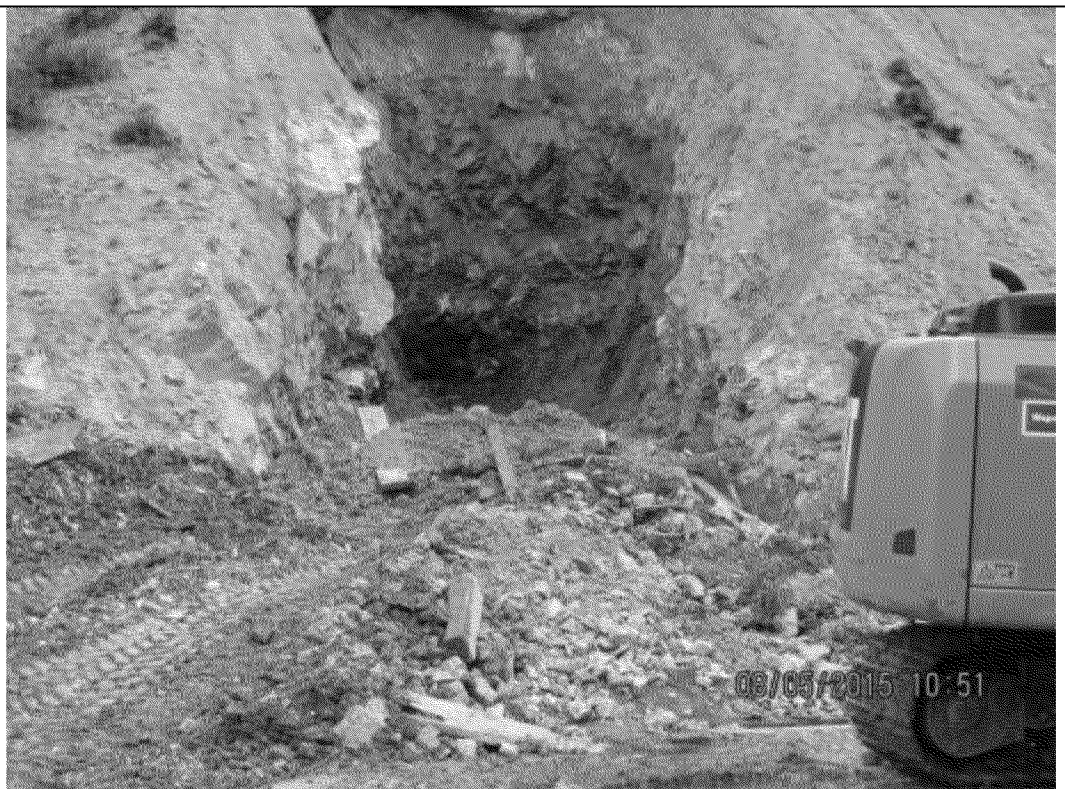
Photo No.
16

Cleaning out excavated material, small leak.

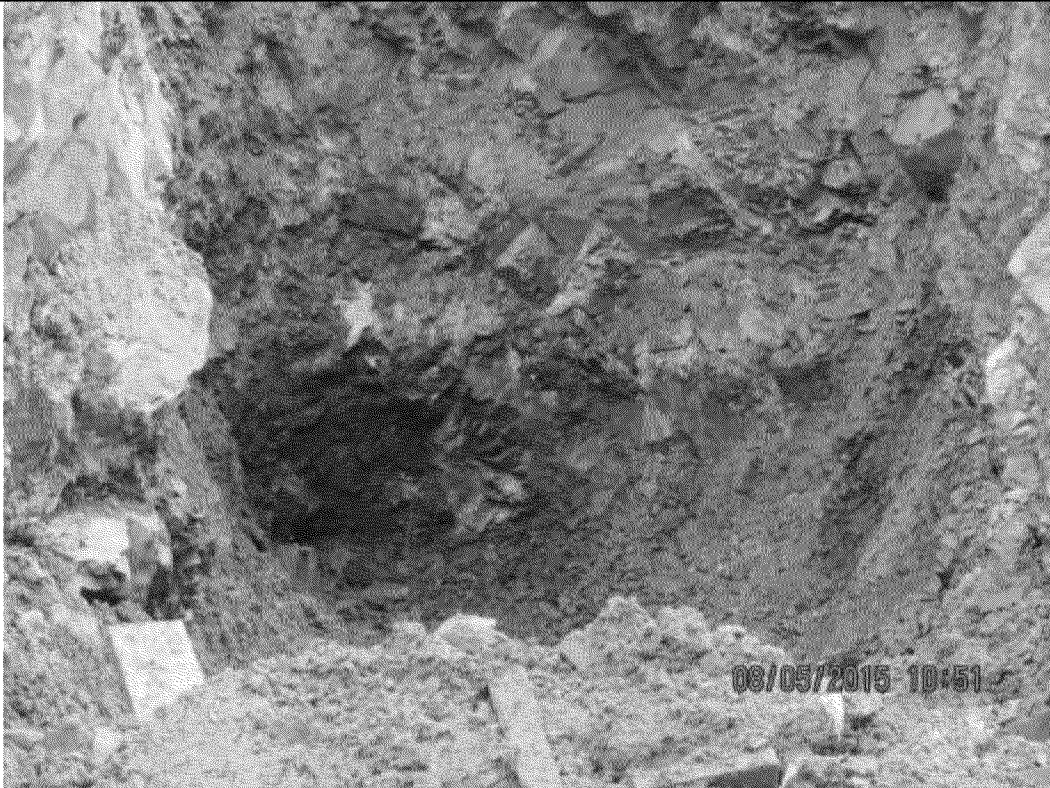
<p>Direction Photo Taken:</p> <p>North</p>		
<p>Description: Small leak close up.</p>		
<p>Photo No. 18</p>	<p>Date: 08/05/2015</p>

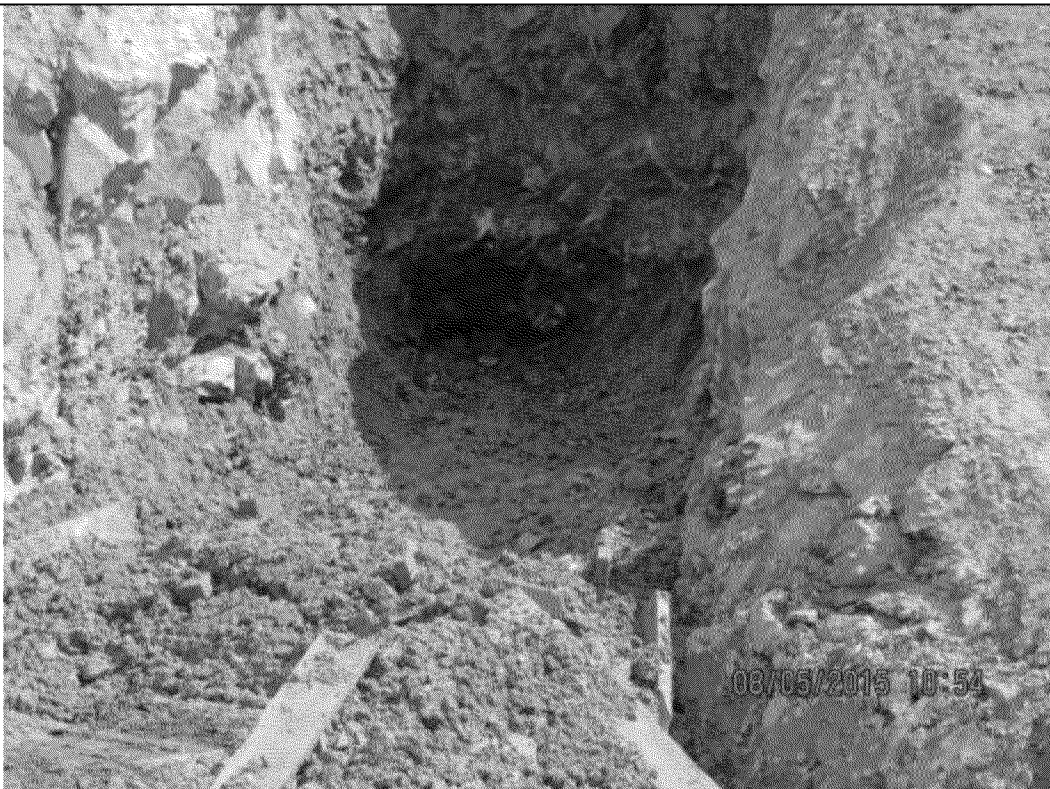
<p>Direction Photo Taken:</p> <p>North</p>		
<p>Description: Hole starting to give way to flow.</p>

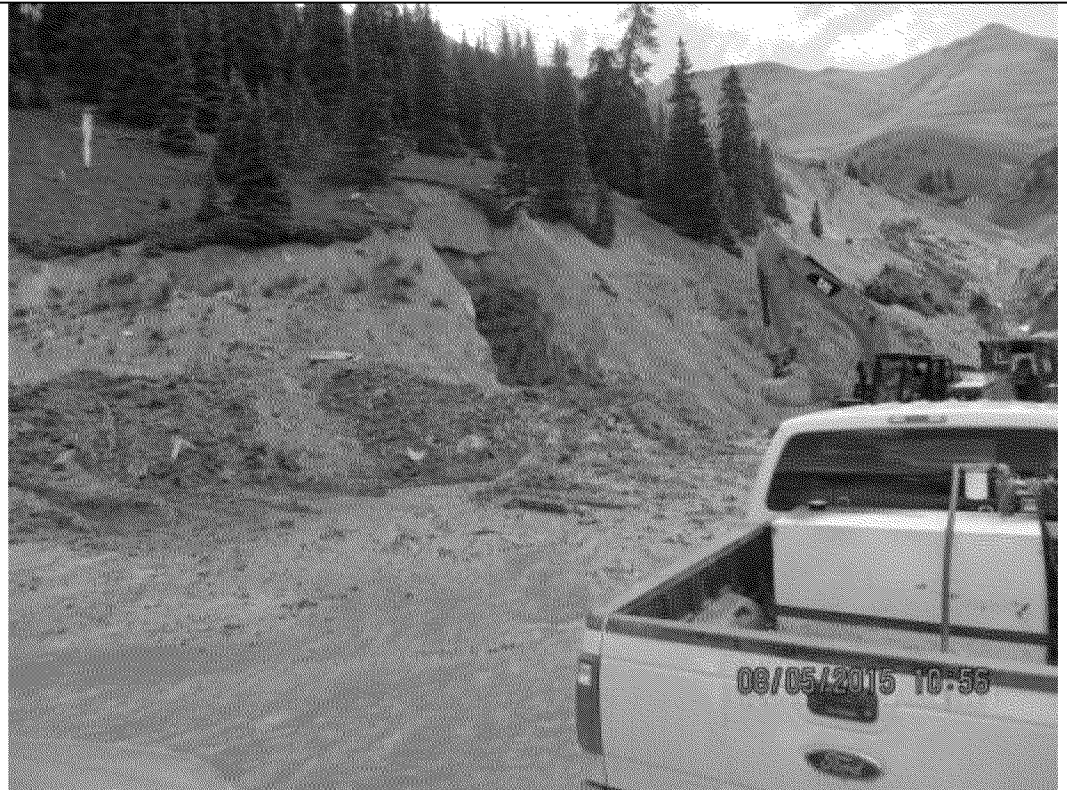
**Photo
No.
19**

Adit flow increasing.

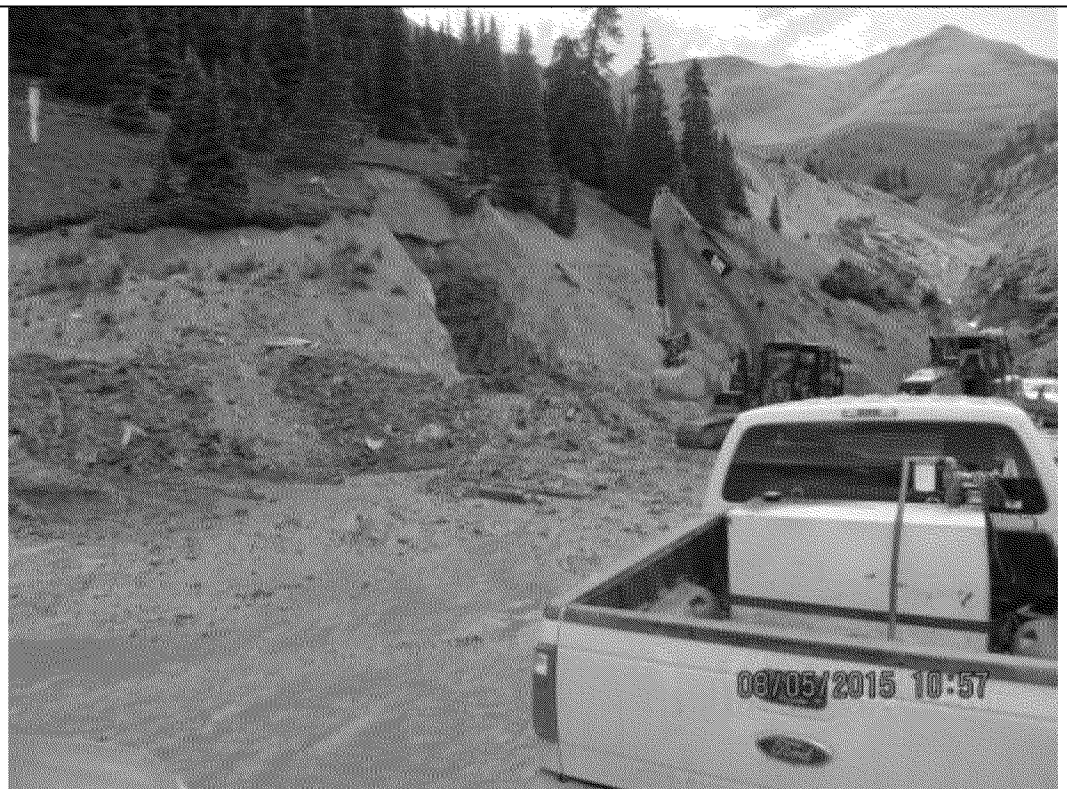
**Photo
No.
20**

Water flooding out at
increased rate.

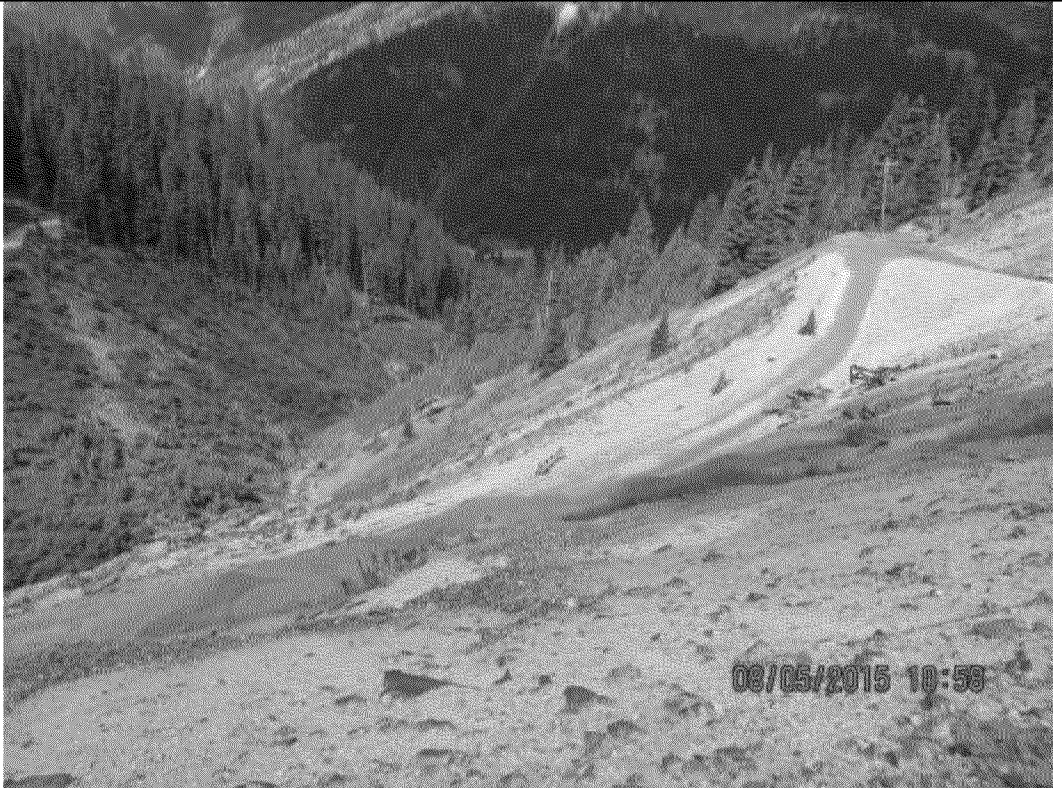
Photo No. 21	Date: 08/05/2015

Direction Photo Taken: West		
Description: Water flowing along access road and across waste dump.		
Photo No. 22	Date: 08/05/2015

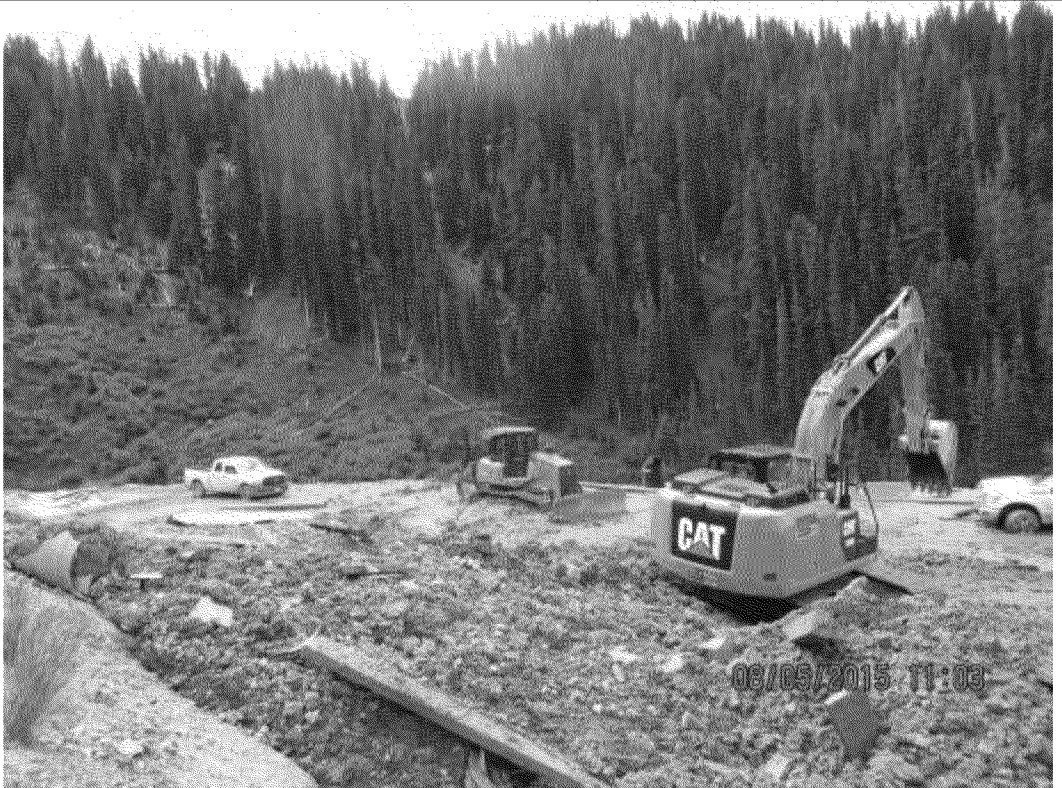
Direction Photo Taken: Southeast		
Description: Water flowing over the edge of the waste dump and collapsing the edge.

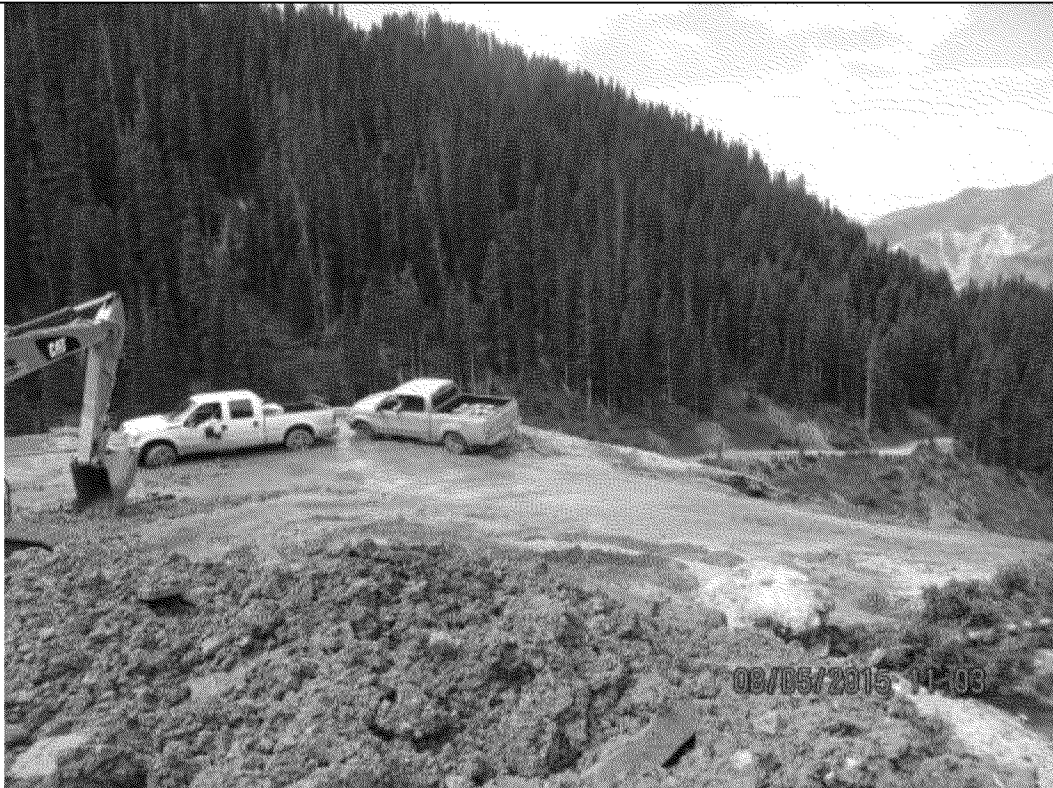
Photo No. 23	Date: 08/05/2015

Direction Photo Taken: Southwest		
Description: Exit route starting to collapse

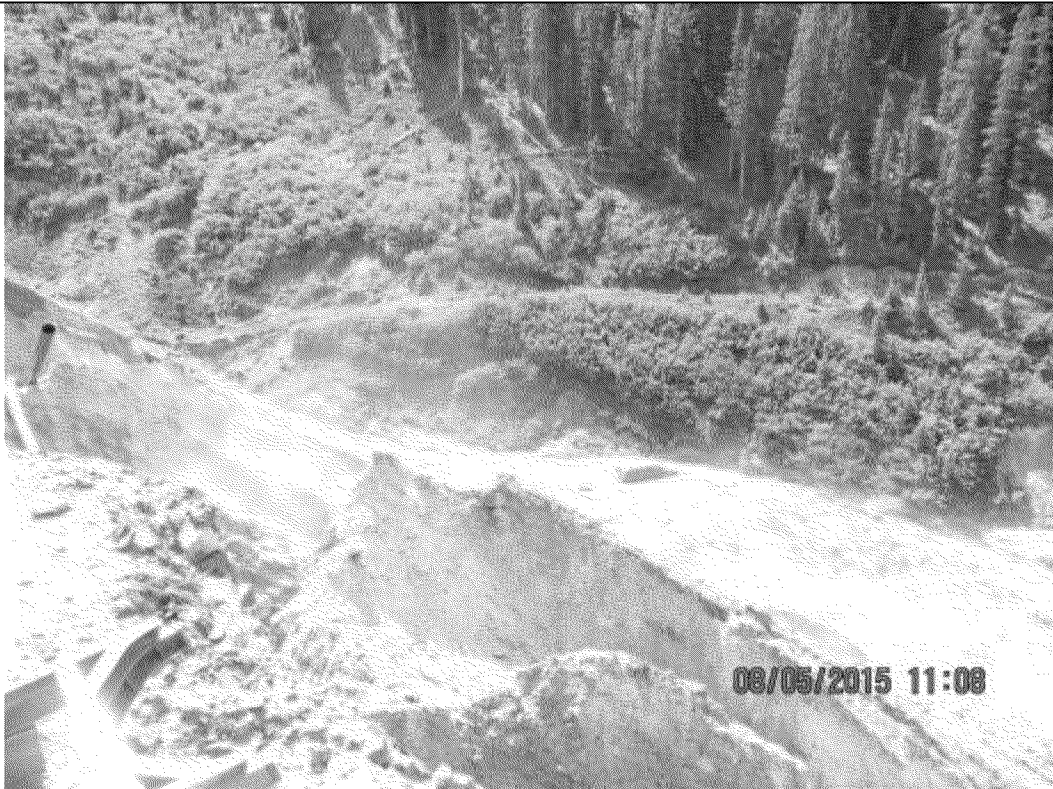
Photo No. 24	Date: 08/05/2015

Direction Photo Taken: Southeast/Down		
Description: Edge of the tailings dump collapsed, suburban trapped and half submerged in center of photo.

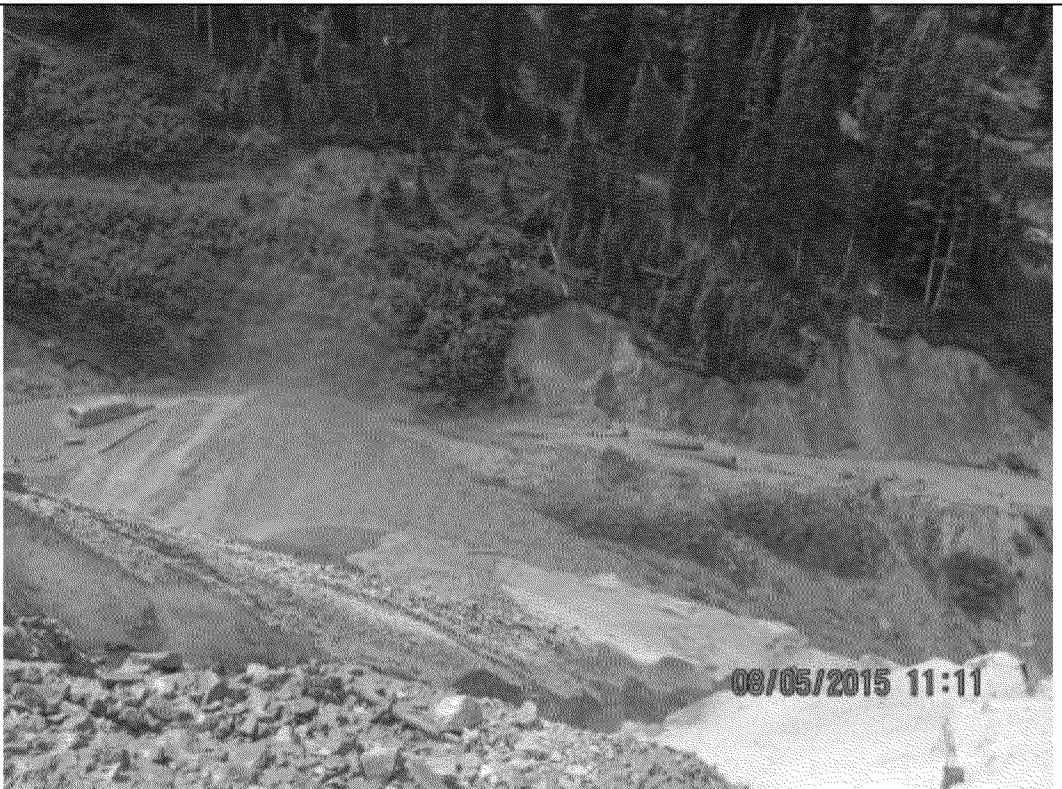
Direction Photo Taken: Southeast		
Description: Water flow washing out the existing road. Note Suburban in left side of photo.

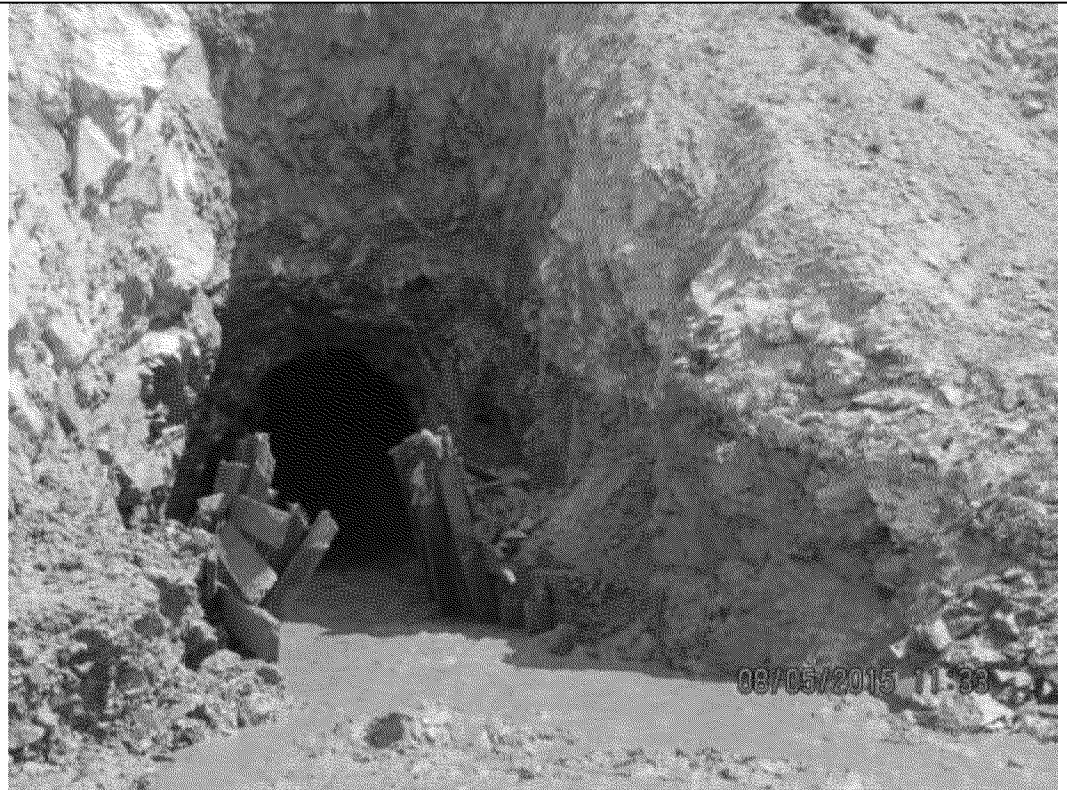
Photo No.
27

Exposed adit, roughly 10 feet wide by 15 feet high.

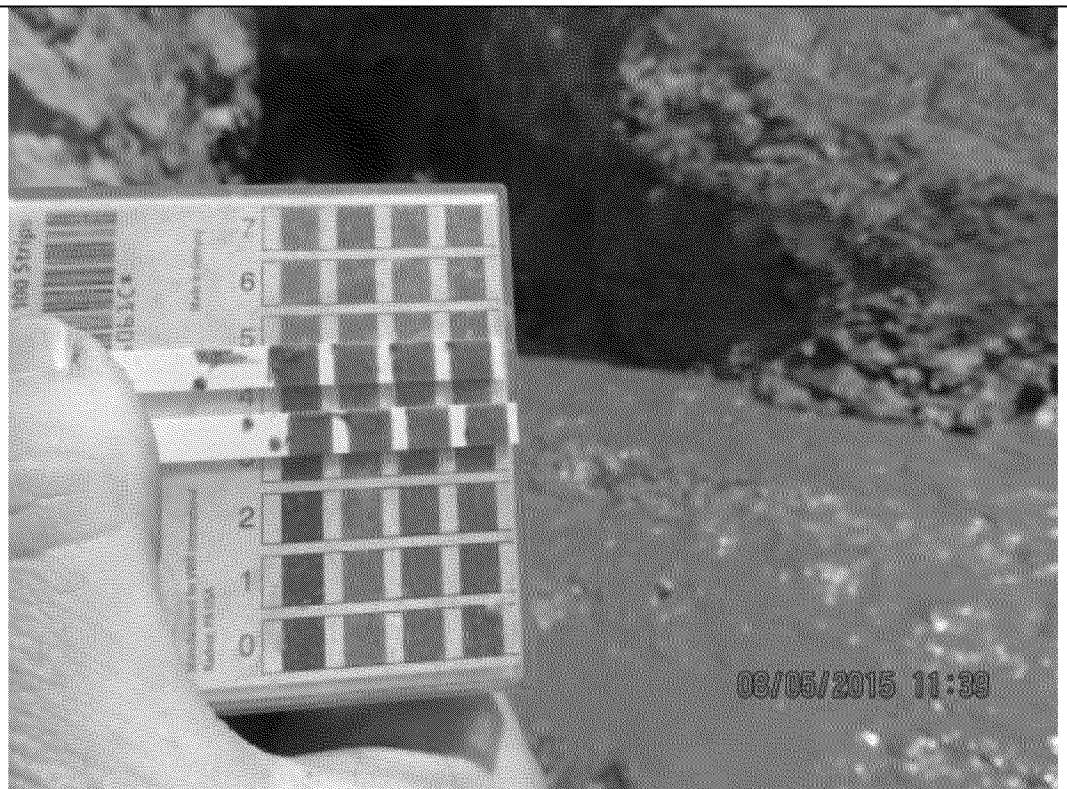
Photo No.
28

pH of discharge water is approximately 4 to 4.5.

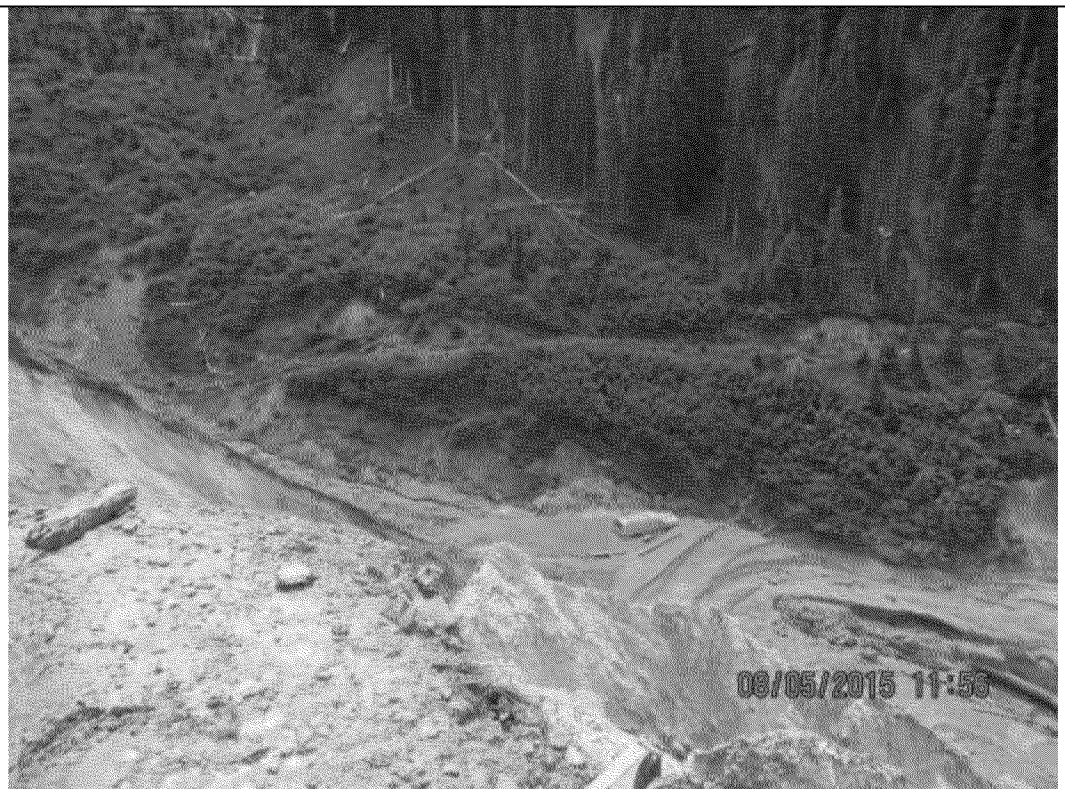
**Photo
No.
30**

Collapsed portion of
waste dump and road
wash out.

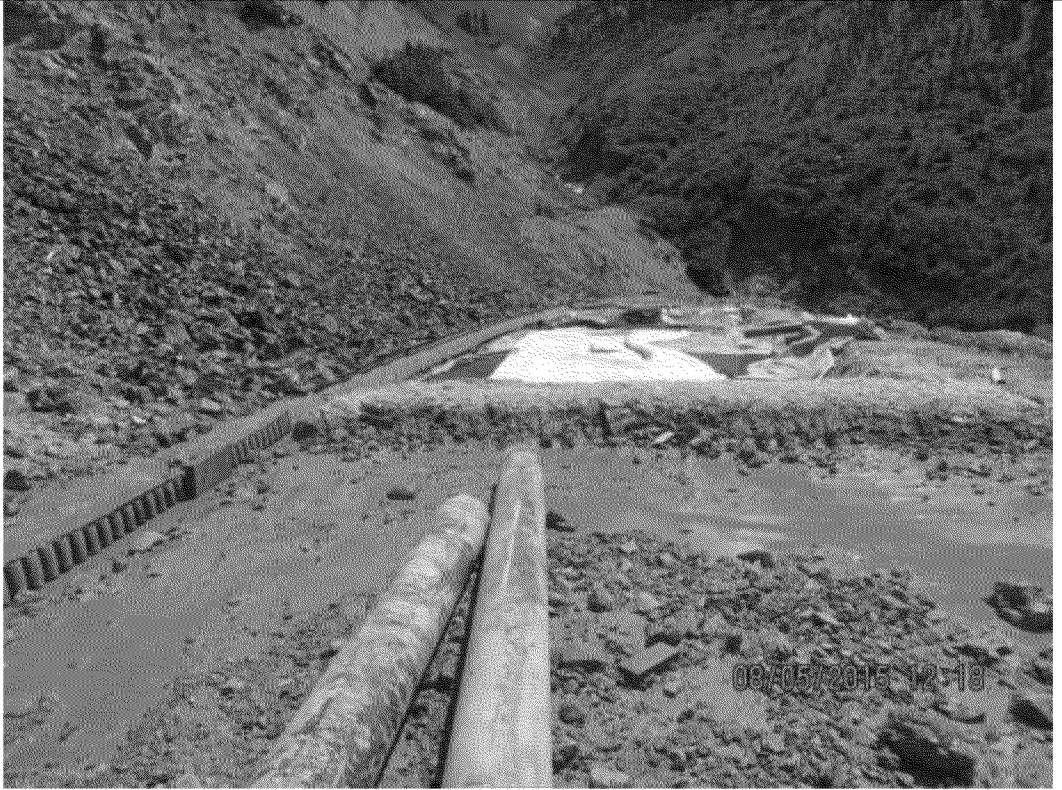
Direction Photo Taken: East		
Description: Existing flow channel at maximum capacity.

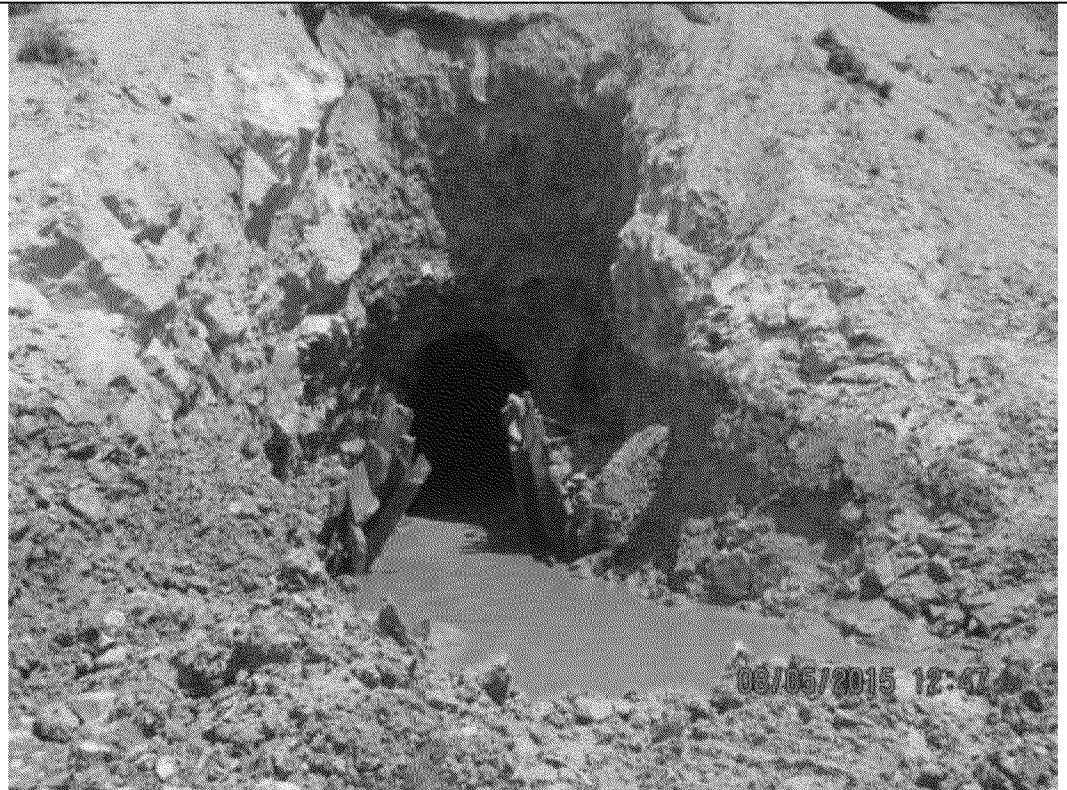
Photo No.
39

No changes visible in adit structure or supports. Sloughing of materials inside the mine can be heard.

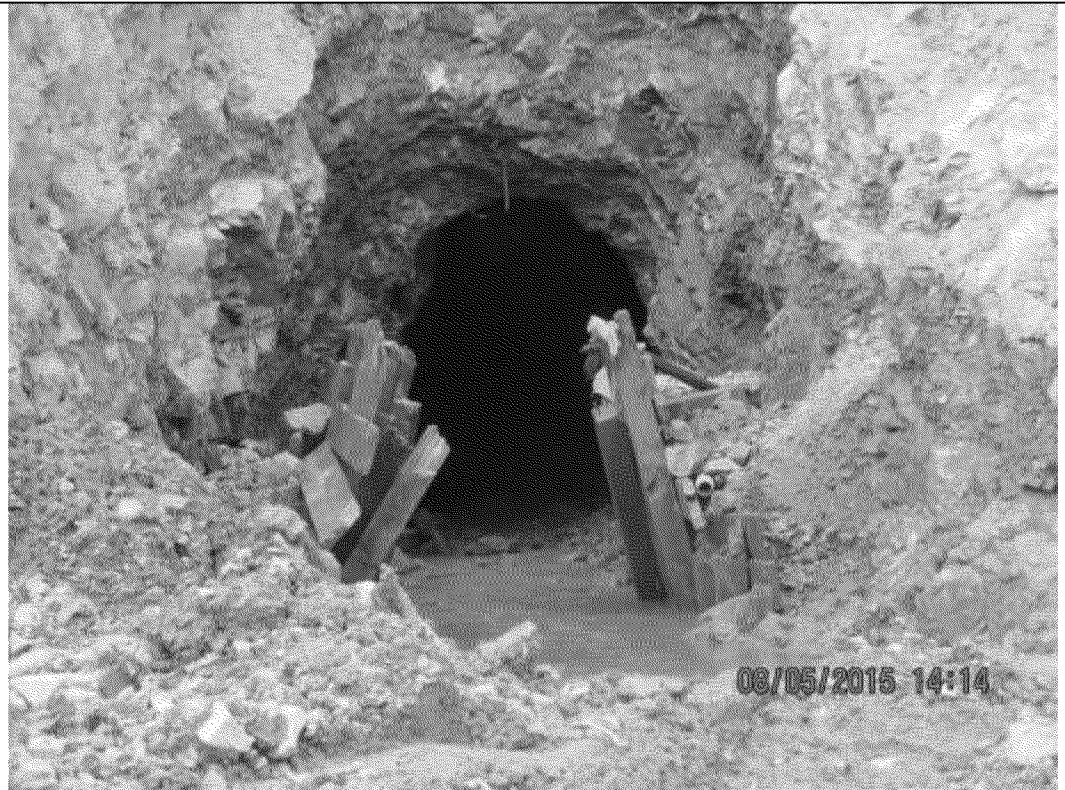
Photo No.
45

Water levels lowering at adit entrance, no visible changes to structure.
